REQUEST FOR PROPOSALS

BRIDGE MAINTENANCE & REHABILITATION PROJECT

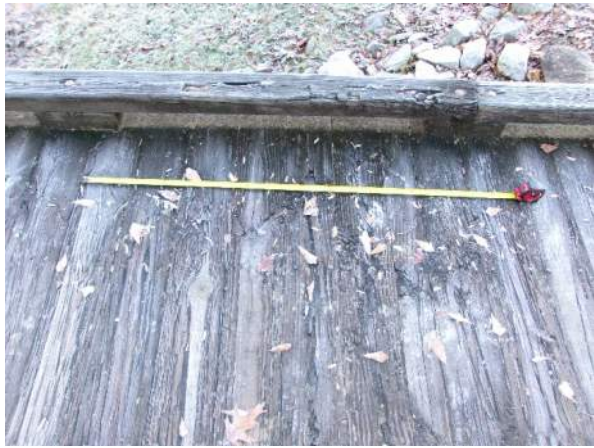
Area of moderate abrasion in Span 4 deck

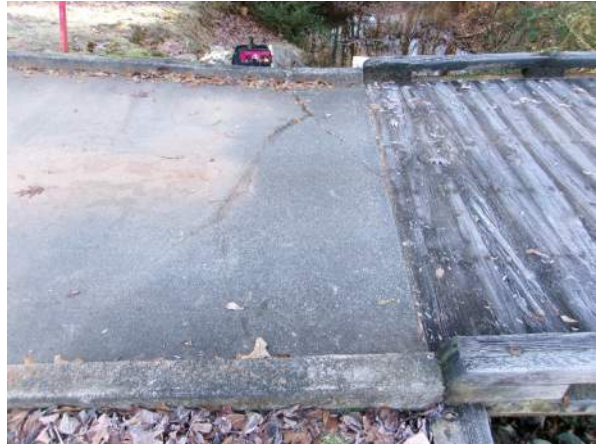
Cracking of approach span at Bent 5

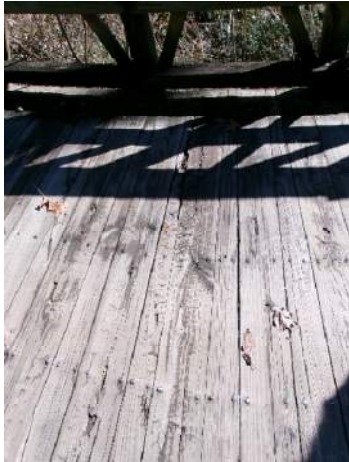
Typical area of deck boards with minor abrasion

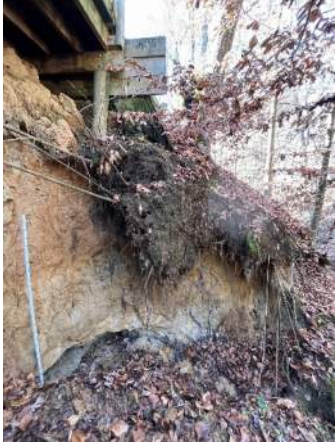
Soil failure at Bent 8

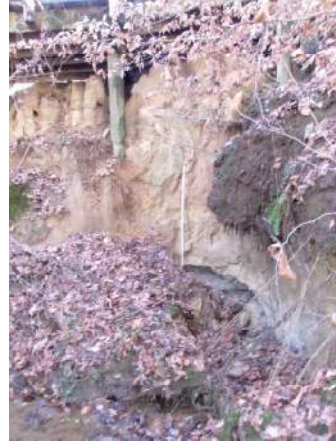
Soil failure at Bent 7 (Pile 2 at Bent 7 shown)

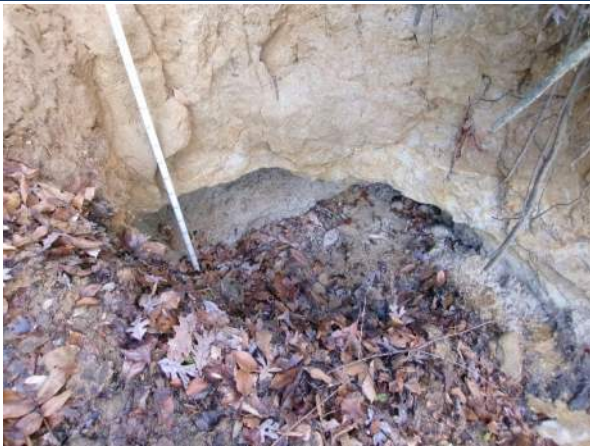
Scour hole forming at the bottom of soil failure between Bents 7 and 8

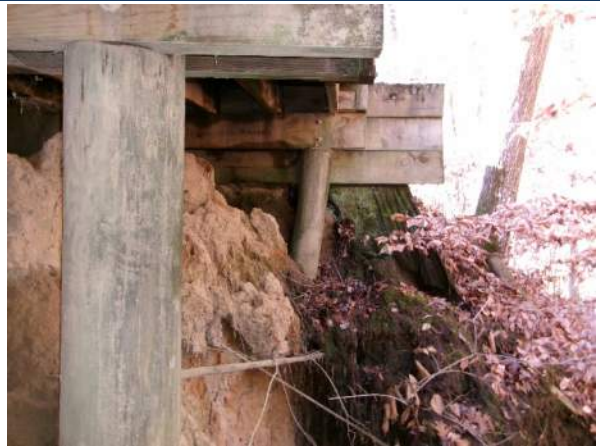
Top of Pile 2 at Bent 8 that is battered outward at the top of pile

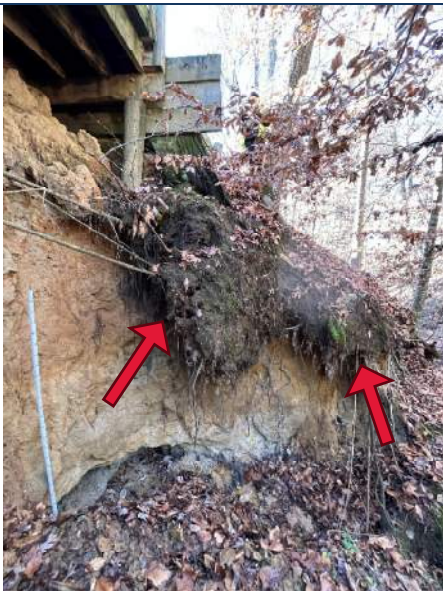
Soil failure at Bent 8, red arrows are pointing at tree root system

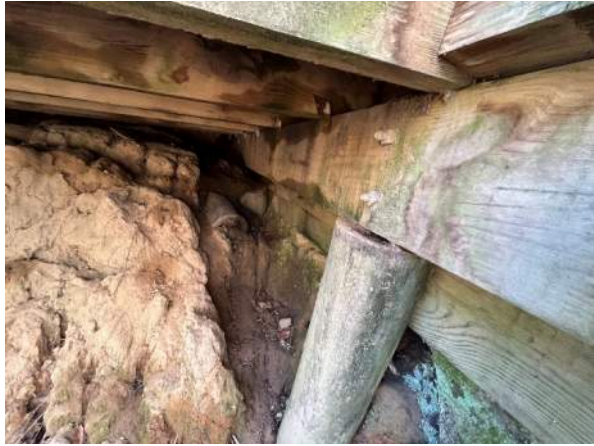
Top of Bent 8, Pile 1 is below grade

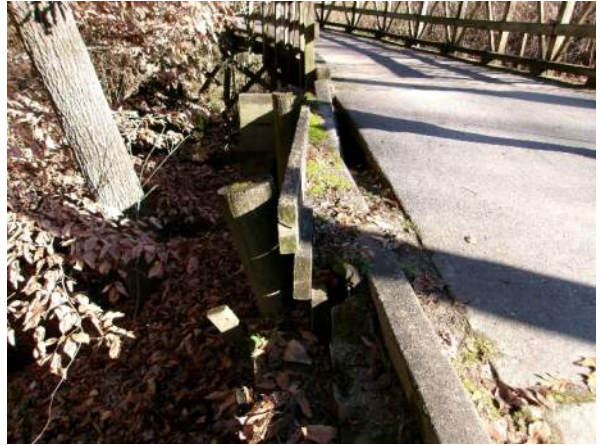
Timber wing wall failing at Bent 8 right (looking back)

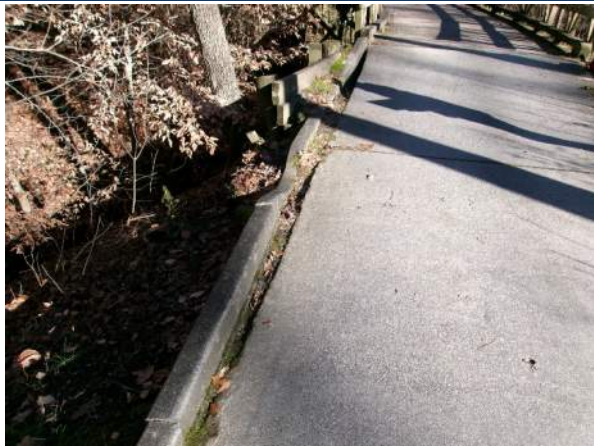
Bent 8 wing wall and curb failing (looking back)
Note the oak tree leaning away from bridge

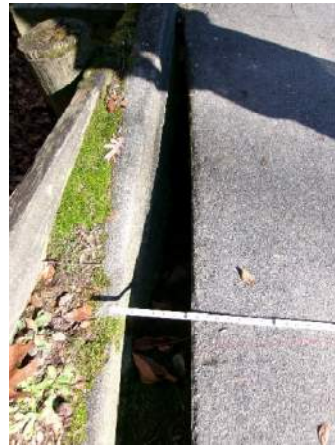
Curb at Bent 8 right failing between concrete pathway

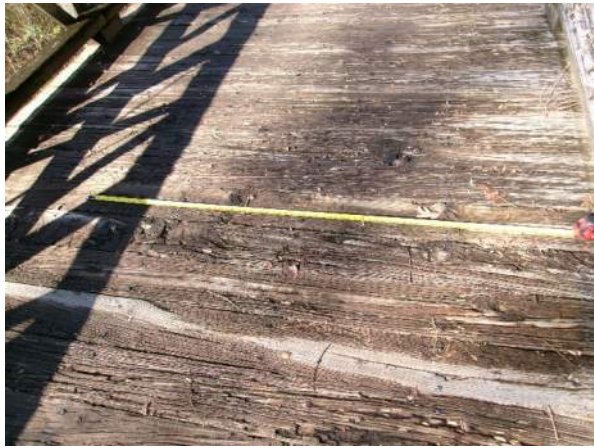
Typical area of deck boards with heavy abrasion

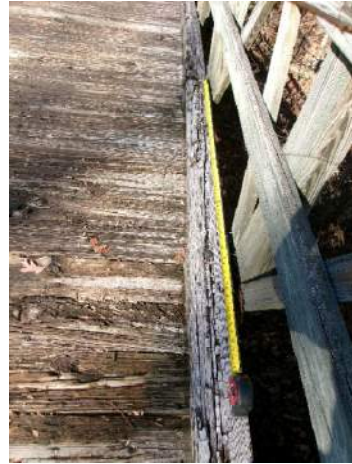
Typical splits and rot along top of brush curbs

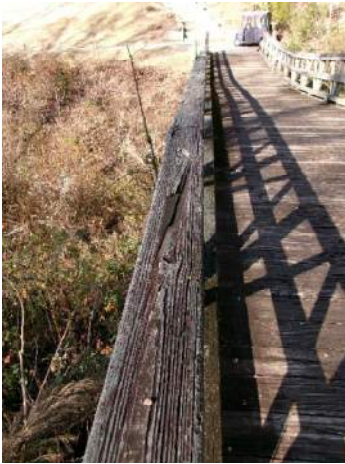
Splitting and rotting of handrail top board

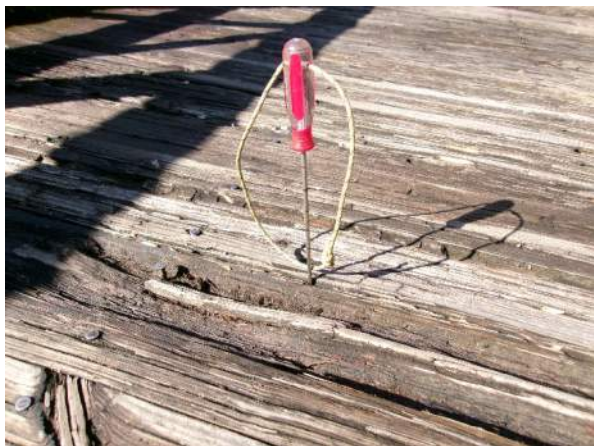
Section loss and rot of deck boards

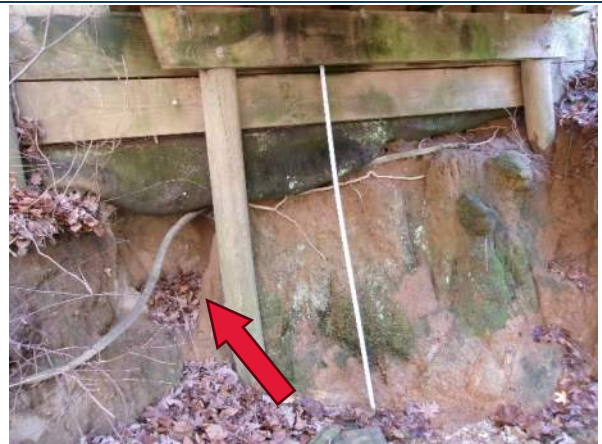
Erosion of endroll at Bent 1 (looking back), red arrow points to 2'-0" diameter hole at Pile 2

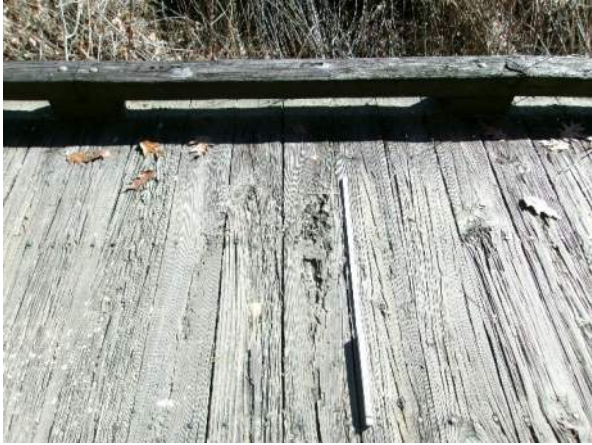
Moderate abrasion on 25% of deck and brush curbs

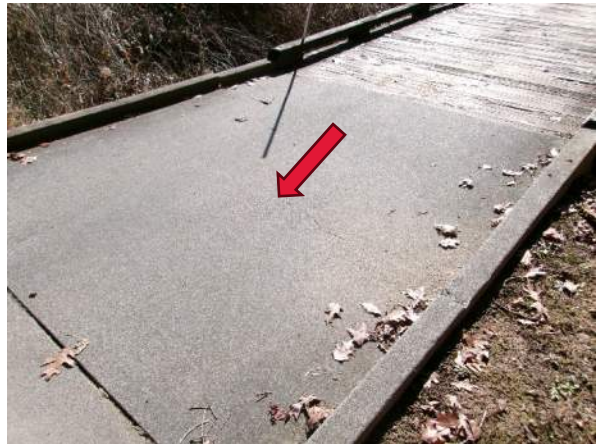
Approach slab at Bent 1 cracking with differential settlement

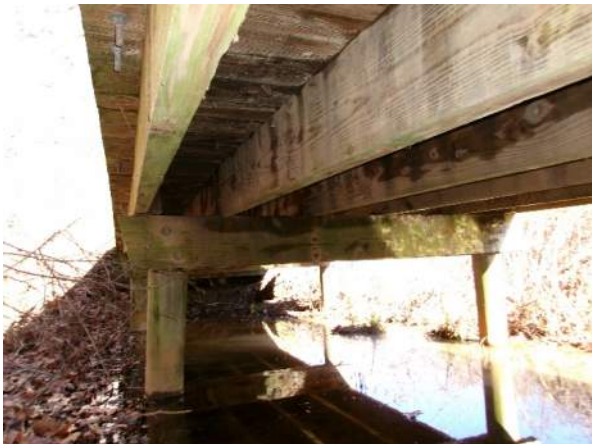
Typical underside (looking back)

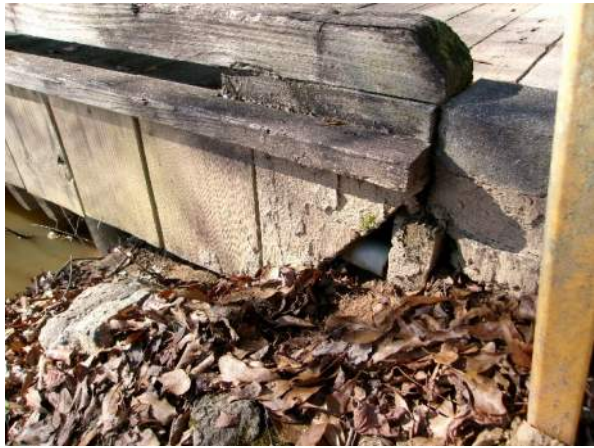
Timber façade covering 2" diameter PVC utility

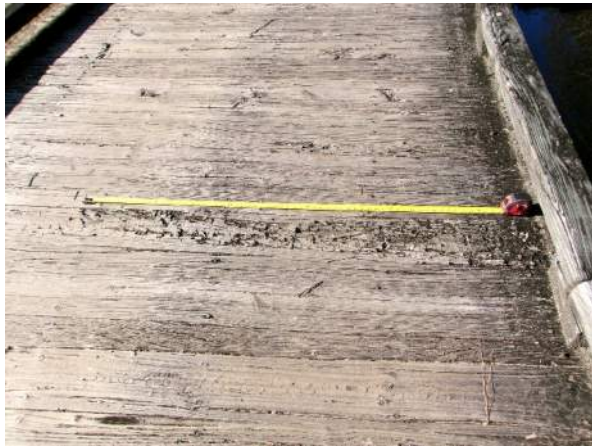
Typical area of deck boards with heavy abrasion

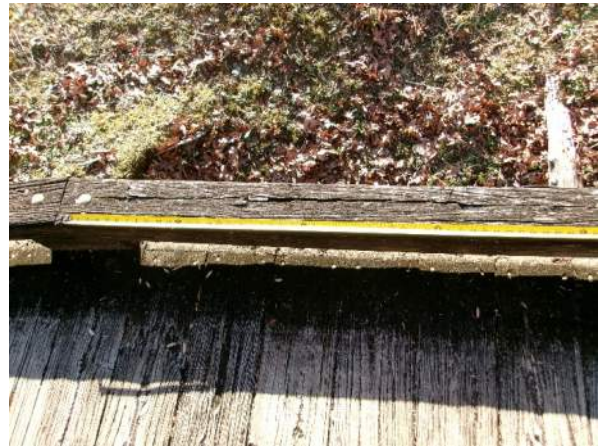
Typical splits and rot along top of brush curbs

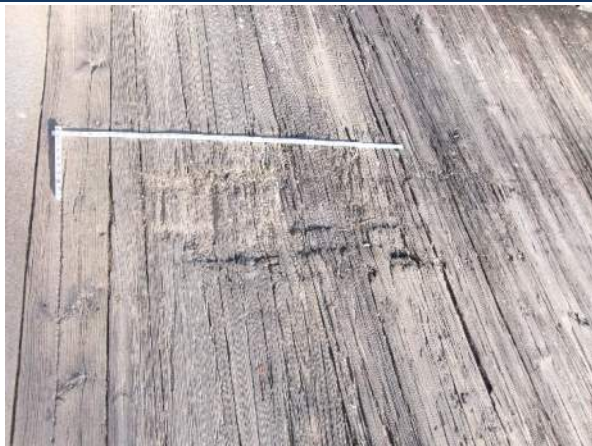
Area of section loss in Span 5 that measures 3'-0" x 2'-0" and up to 1" deep

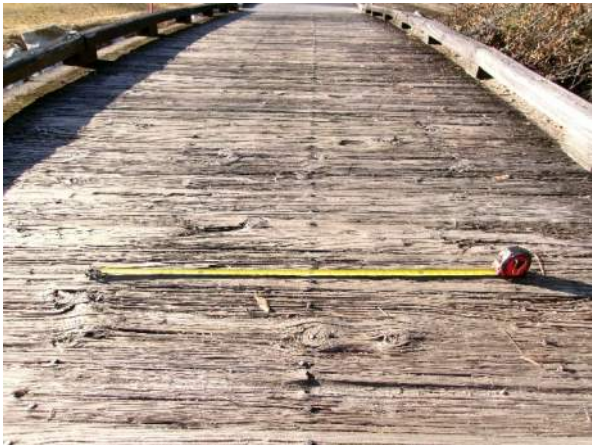
Typical area of deck boards with heavy abrasion

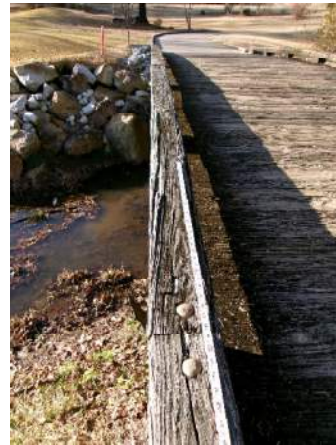
Typical splits and rot along top of brush curbs

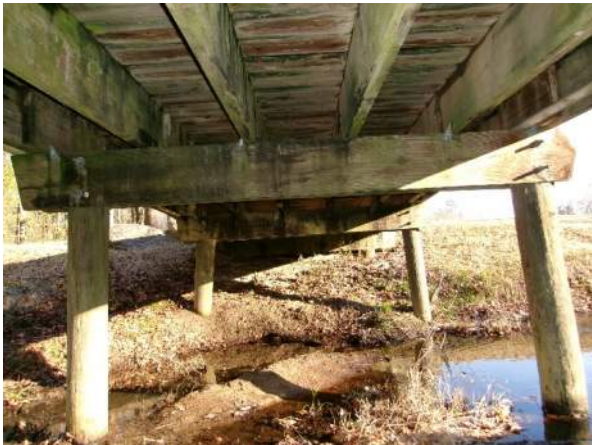
Typical underside of bridge (looking back)

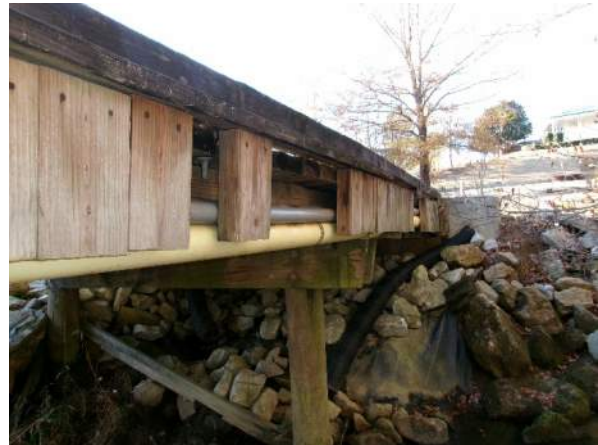
Missing sections of utility façade

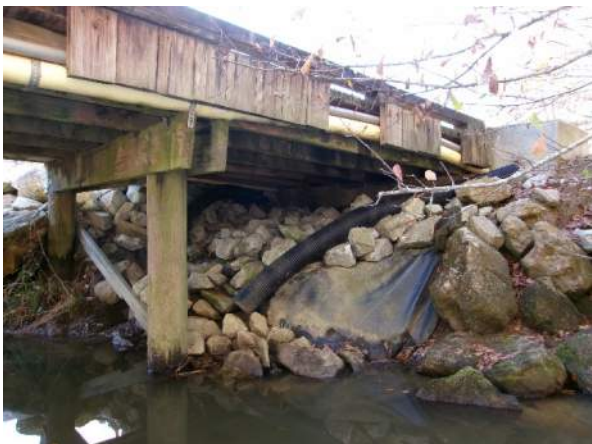
Rip rap missing exposing filter fabric

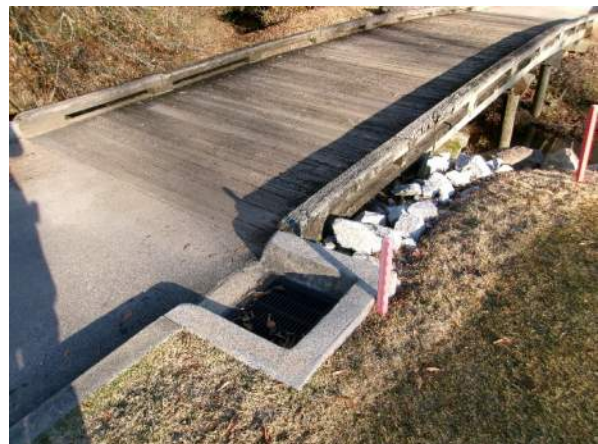
New drop inlets and rip rap added to Bent 5

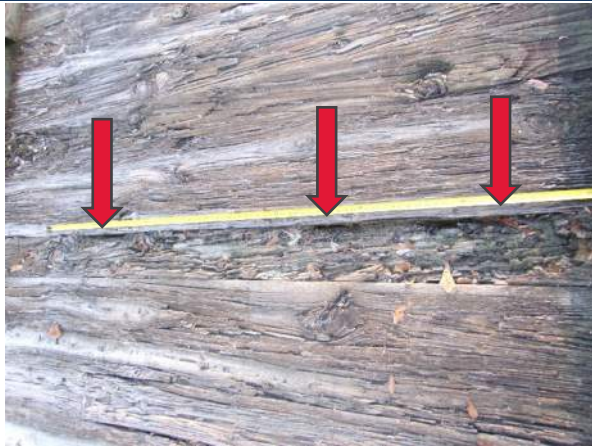
Area of heavy abrasion in Span 2 deck board (holes highlighted by red arrows)

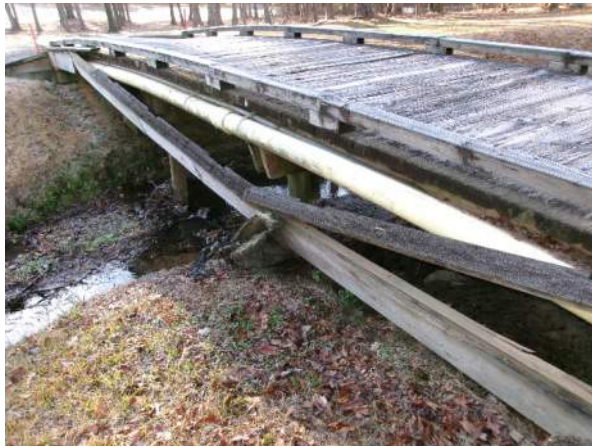
Timber utility façade failing

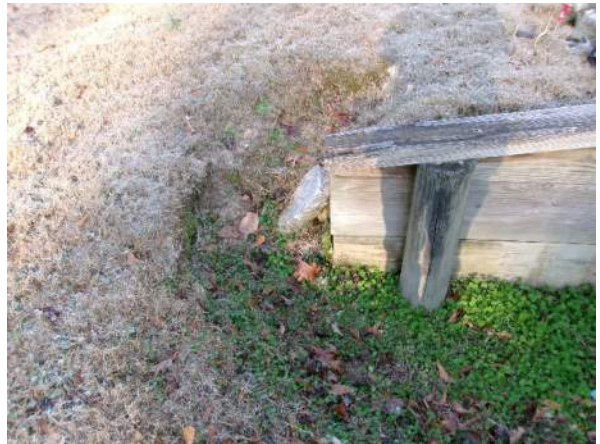
Typical scour hole forming at ends of wing walls at Bent 1

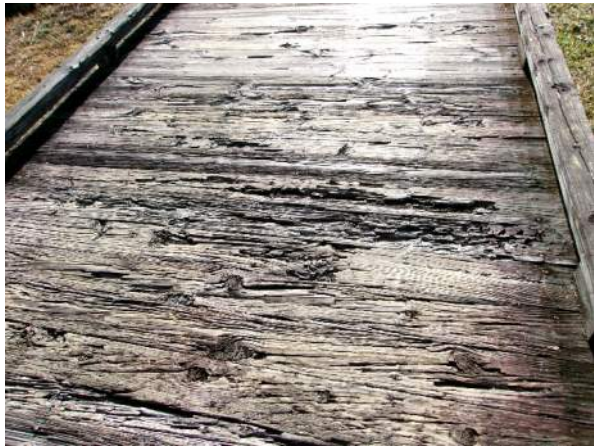
Typical area of deck boards with heavy abrasion

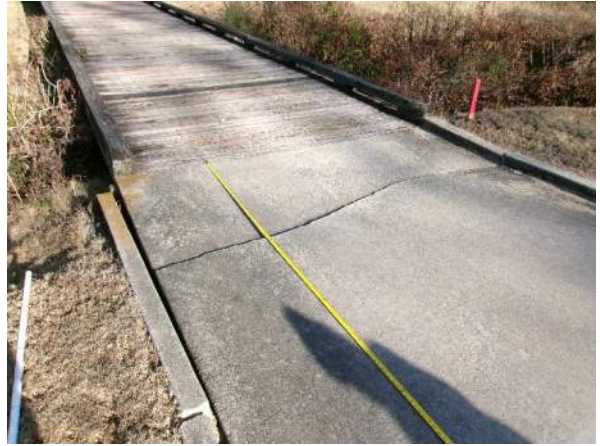
Crack in approach span at Bent 1

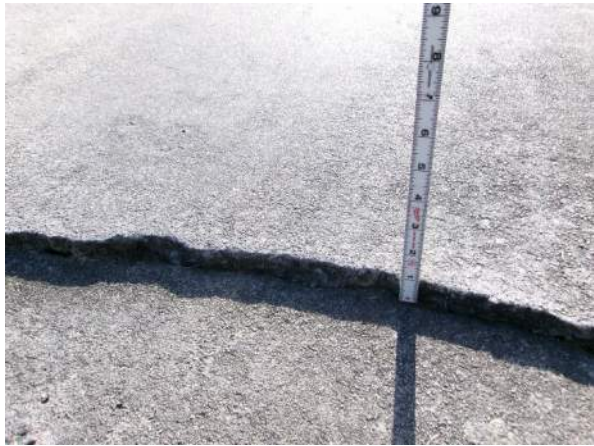
Settlement in approach span at Bent 1

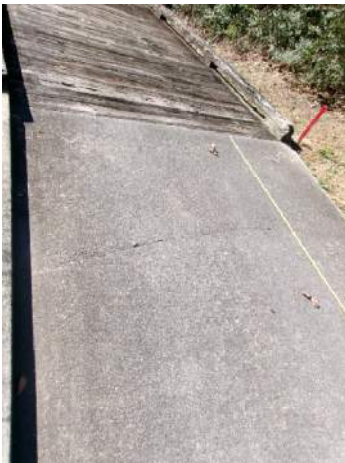
Crack in approach slab at Bent 27

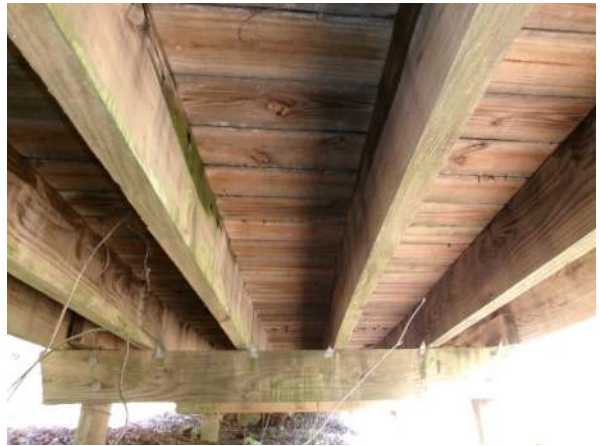
Typical bridge underside (looking ahead)

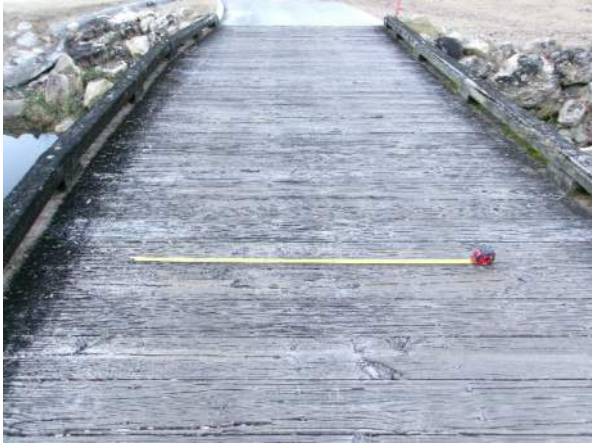
Typical area of deck boards with moderate abrasion

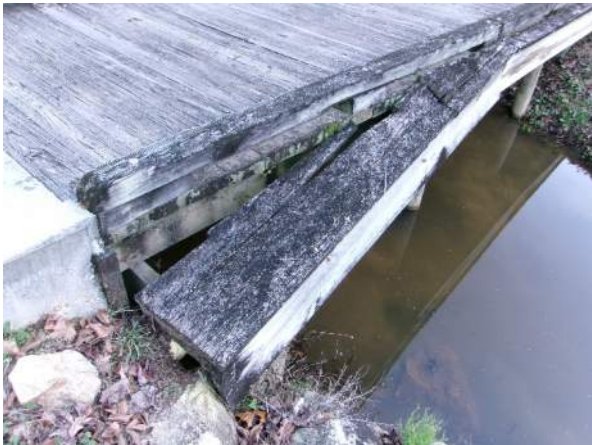
Timber utility façade failing in Span 3

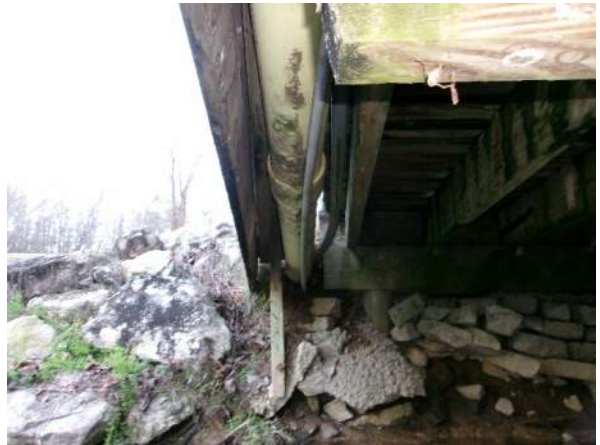
Utilities along left side of bridge deck

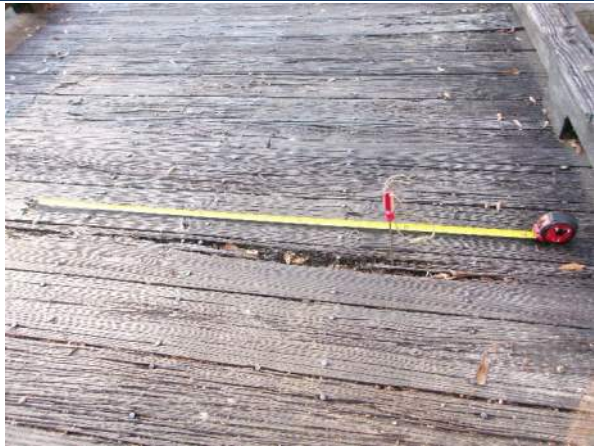
Typical of deck boards with abrasion and 1 1/2" of awl penetration

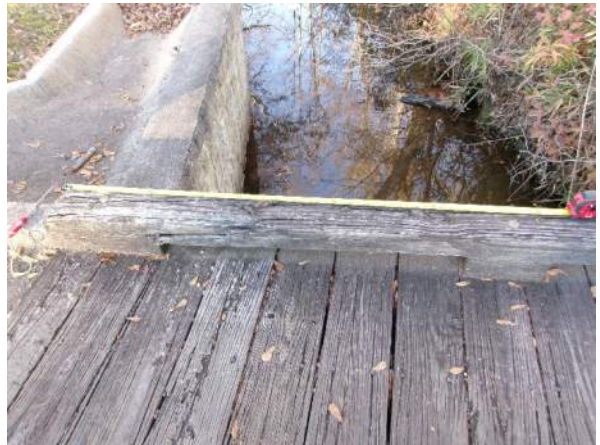
Typical splits and rot along top of brush curbs

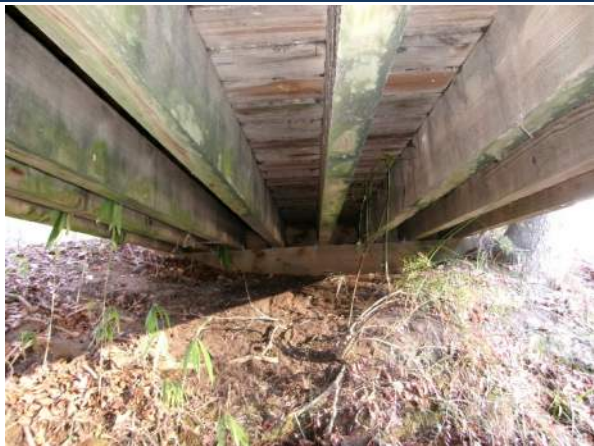
Typical underside of bridge (looking back), Bent 1 piles are below grade

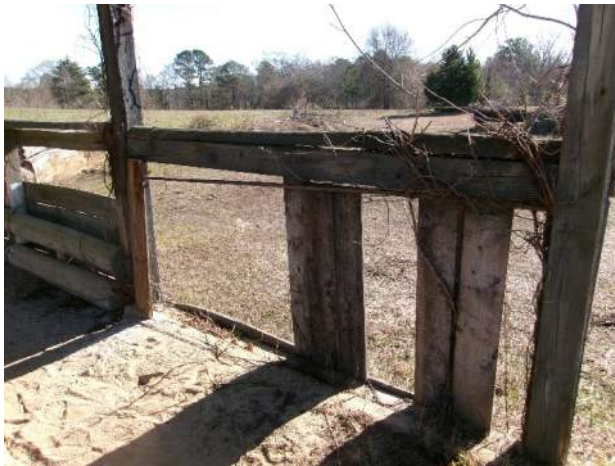
Handrail paneling missing

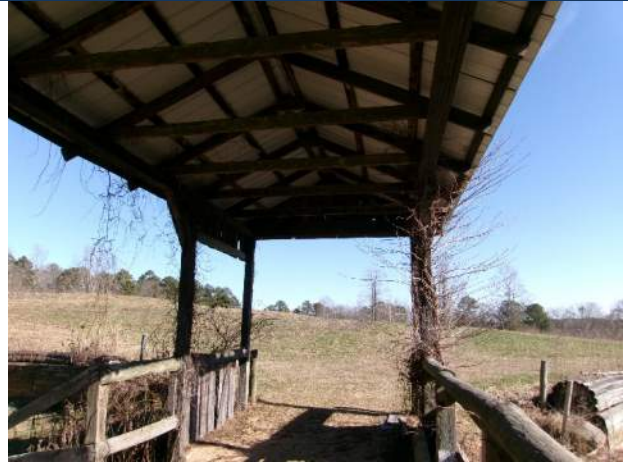
Typical of roof structure and vines growing on bridge elements

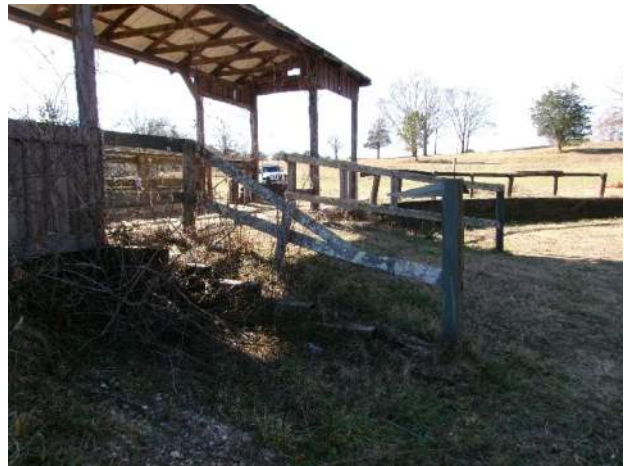
Ramp handrail failing

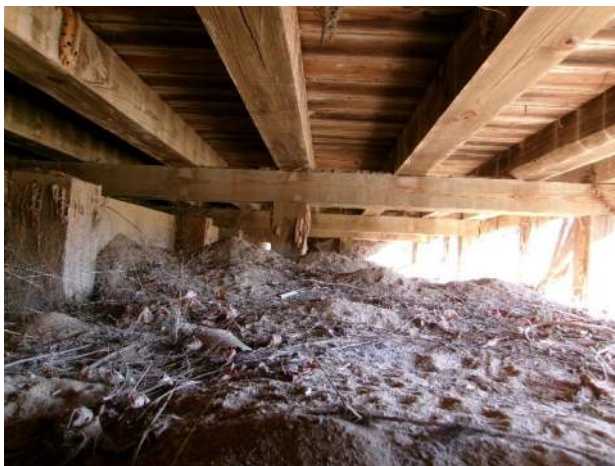
Typical underside of bridge (looking ahead)

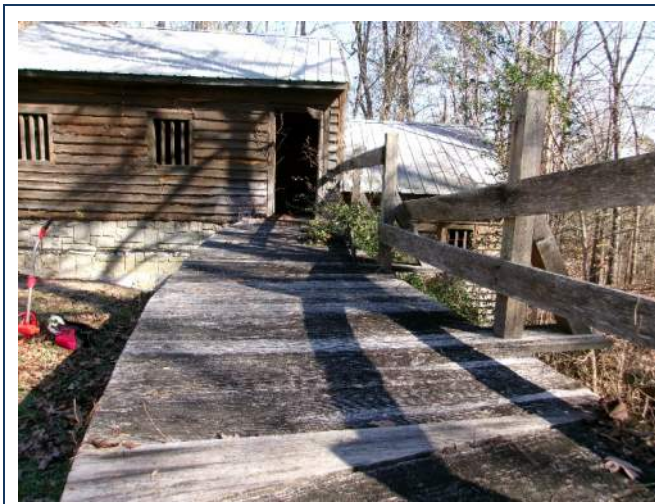
This structure consists of a 28'-4" long timber deck approach that rests on a masonry wall foundation that transitions onto the main timber bridge with a length of 24'-3". The bridge portion consists of 7 spans with an average span length of 3'-6". The deck measures 5'-3" out-to-out. The timber decking is constructed from 2"x12" deck boards. A timber handrail is present on only the right side of the approach and bridge. The deck is supported by (2) – 4"x4" stringers spaced 4'-6" apart. The substructure consists of 4"x4" caps supported by 4"x4" posts with 2"x4" cross framing. Additionally, the posts are sitting on the masonry wall foundation.

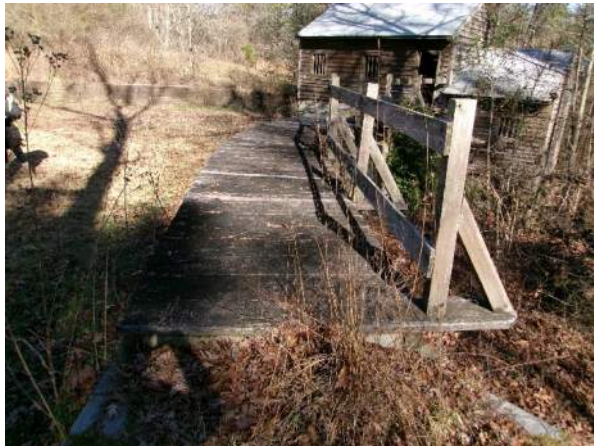
Topside of timber approach and handrail

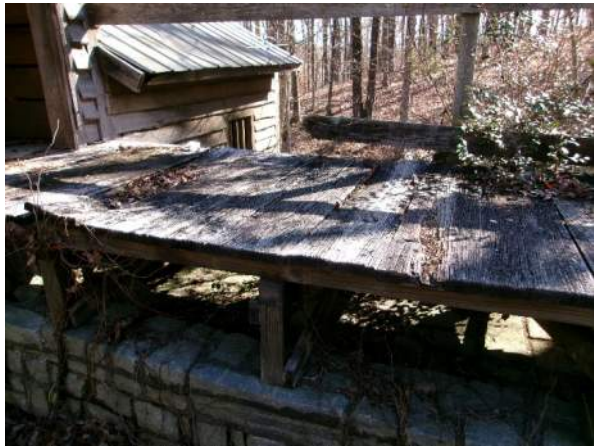
Rotten and failing deck boards in Spans 5-7

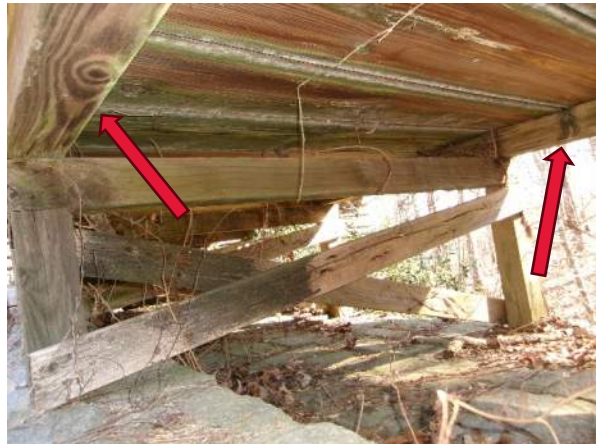
Typical of superstructure, deck boards supported by 4"x4" stringers (looking ahead)

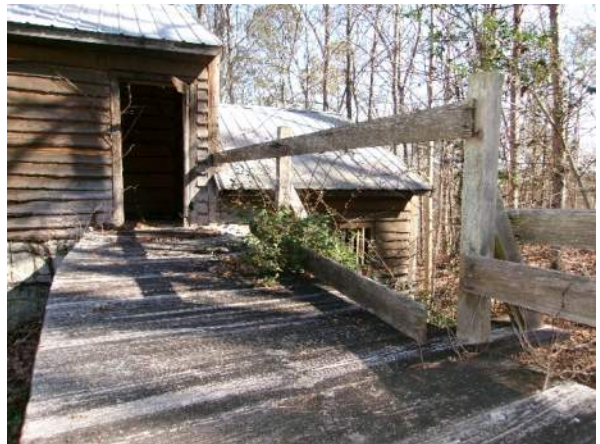
Failing handrail elements

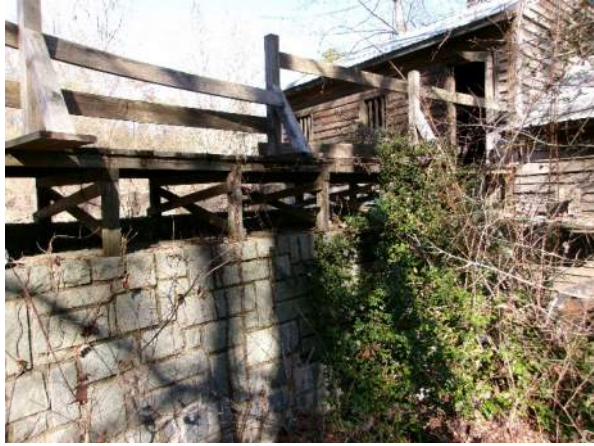
Vegetation growing on right side of masonry wall and substructure elements

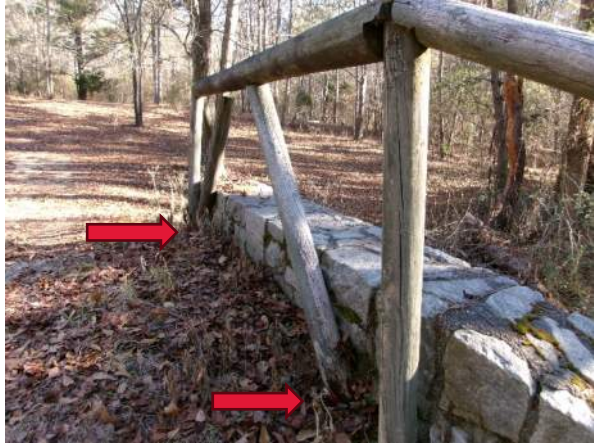
Section loss in handrail members at groundline along right side of culvert

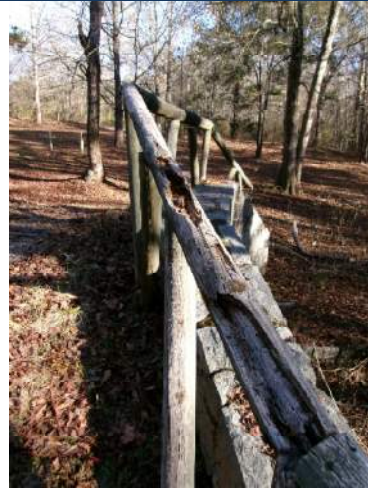
Rot and section loss in top of handrail at right approach

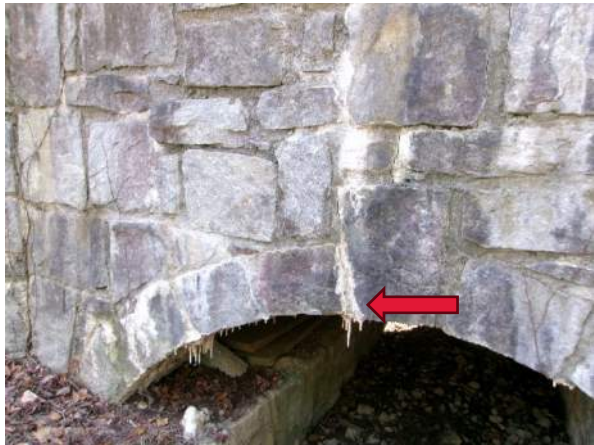
Typical of heavy efflorescence in masonry headwall

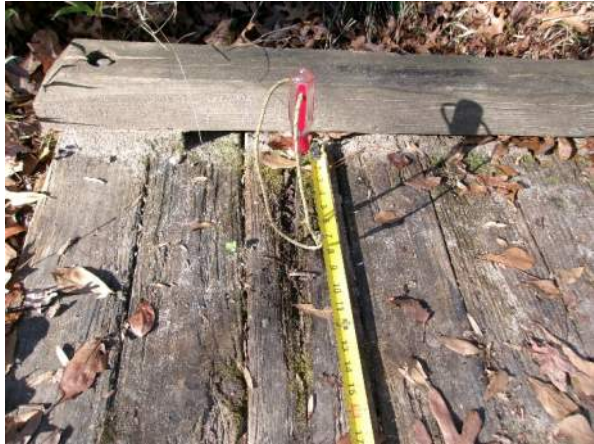
Rot and section loss in deck board along left brush curb at beginning of structure

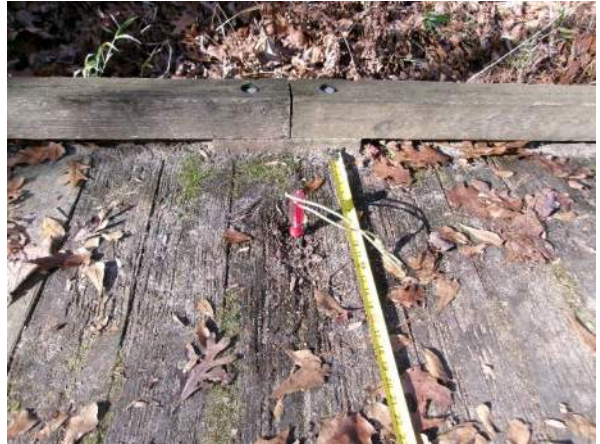
Rot and section loss in deck board along left brush curb at midspan of structure

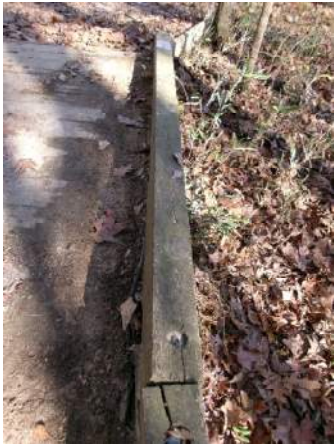
Loose 4"x4" brush curb with missing bolts along right side

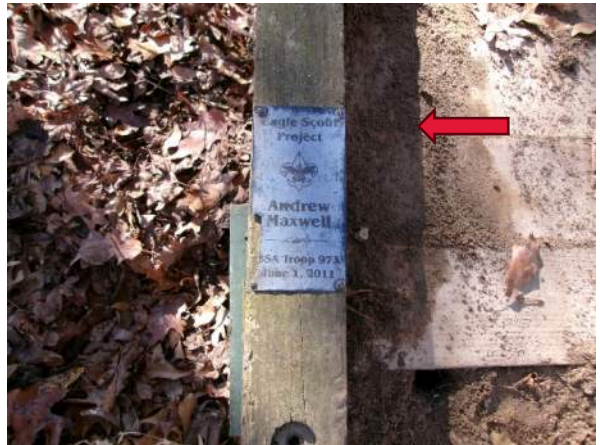
Structure date of construction marker

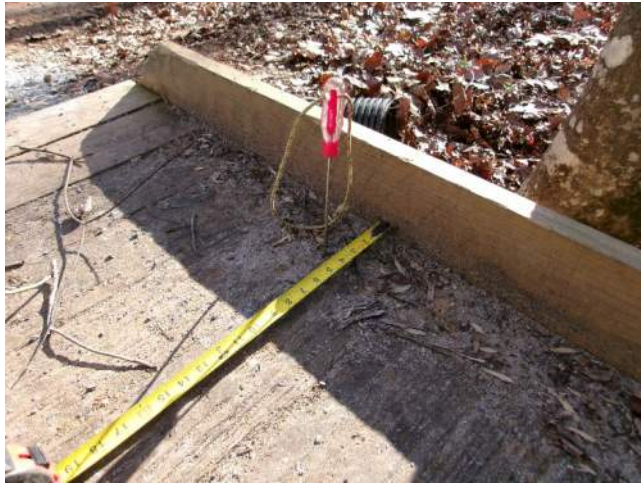
1/2" of awl penetration in areas of soft rot along curb lines

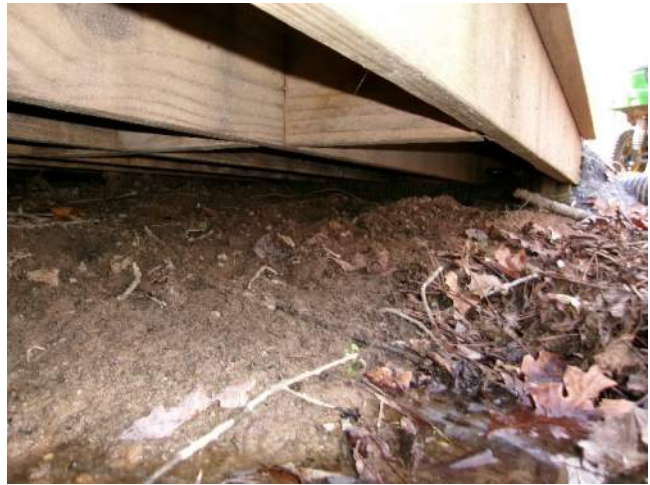
Typical underside (looking back)

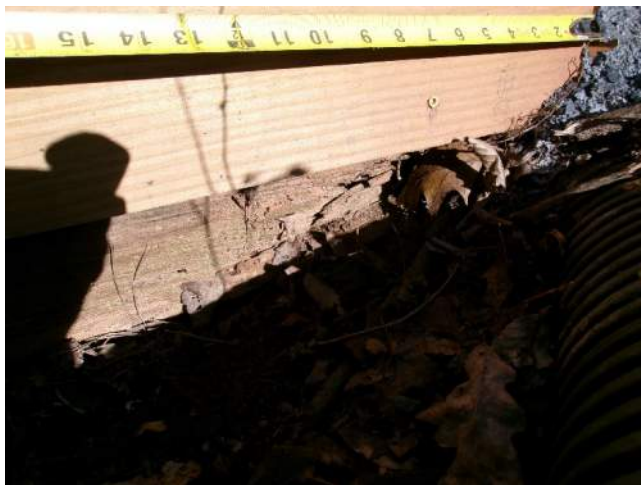
Rot and section loss in left exterior beam at beginning of structure

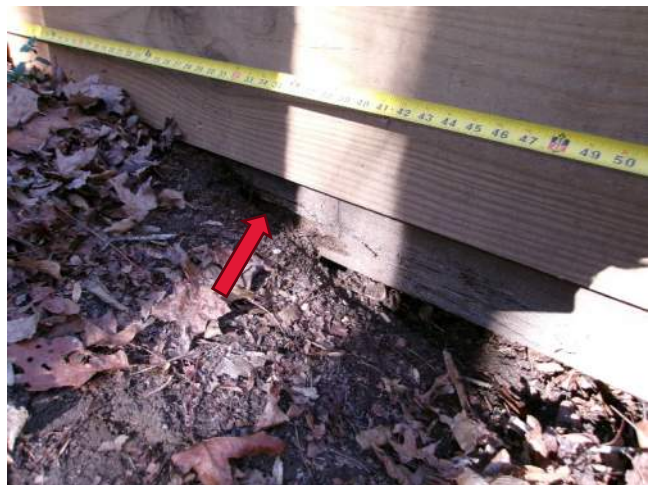
Rot and section loss in left exterior beam at end of structure

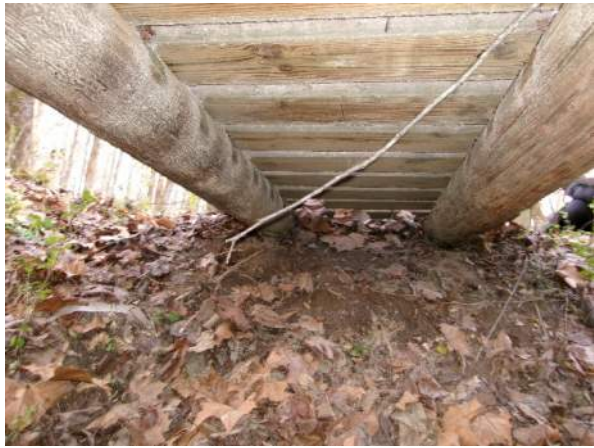
Typical underside (looking back)

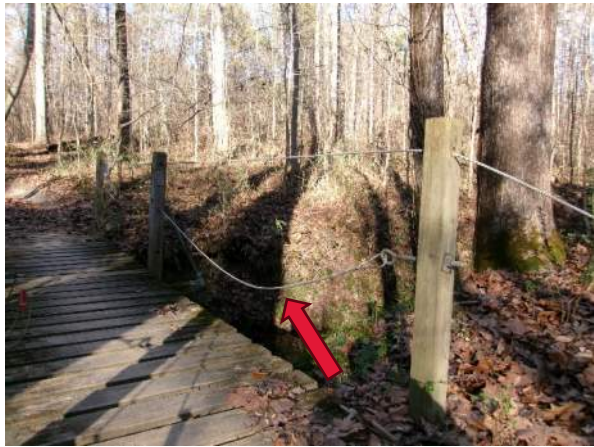
Bottom handrail cable loose

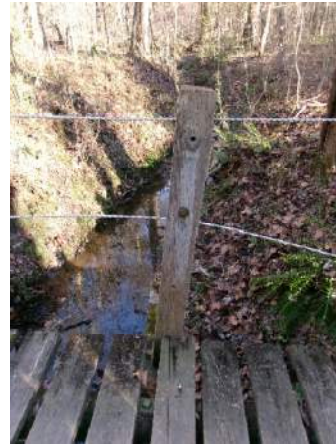
Vertical 4"x6" cable support at midspan, note it is not plumb and can move

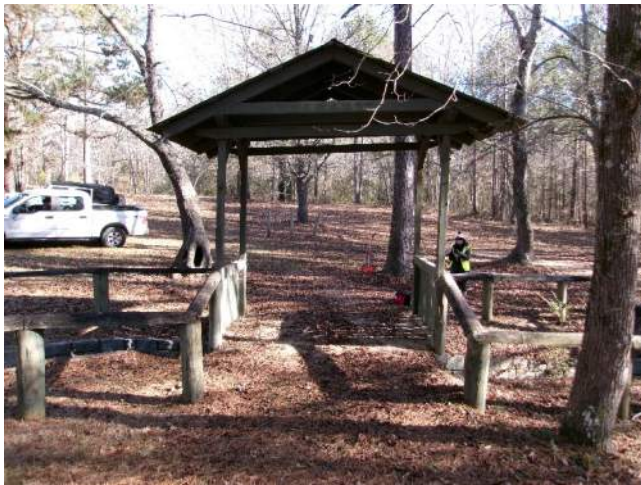
This timber bridge structure consists of a single span with a total length of 6'-3". The deck measures 9'-6" out-to-out. There is a timber handrail with a minimum handrail height of 39". Additionally, there is a roof structure that is comprised of corrugated metal roofing supported by 4"x6" vertical posts. The minimum vertical clearance is 9'-1". The deck is supported by (6)- 4"x6" beams spaced 2' apart. The substructure is constructed with 8" diameter piles that sit on top of masonry walls with an unknown foundation.

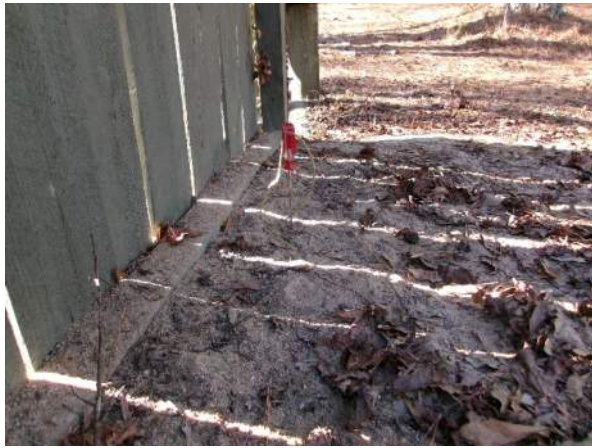
Typical of dirt along deck

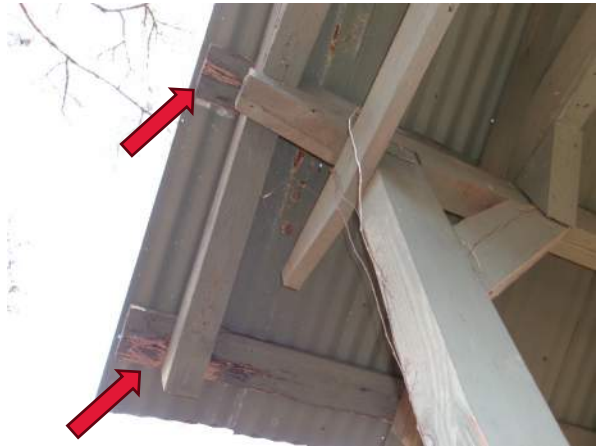
Rot in roof timber members

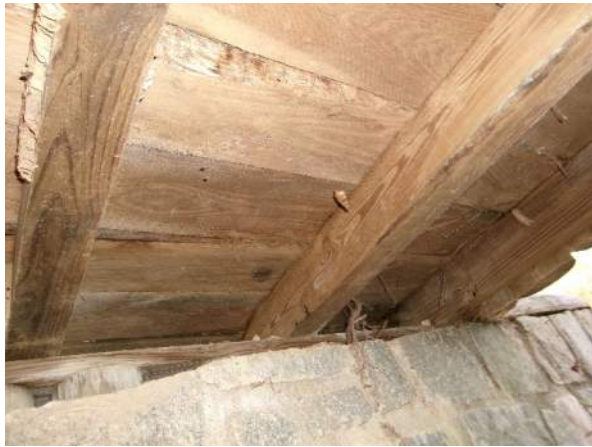
Typical of bottom of decking and superstructure

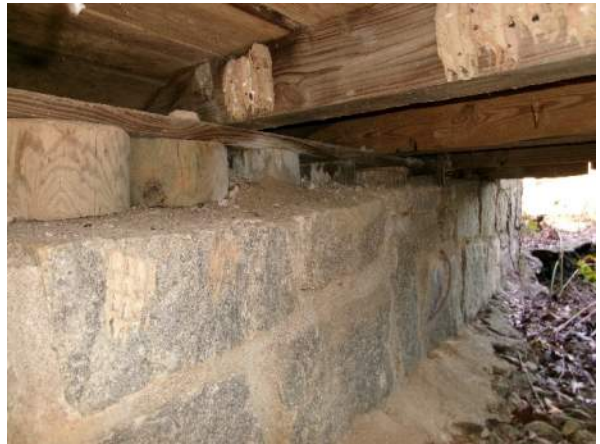
Typical of substructure members on top of masonry wall foundations

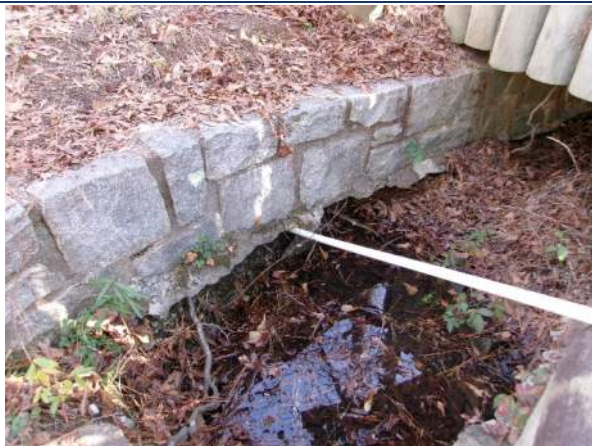
Void and scour hole just down stream from bridge (right masonry wall if looking downstream)

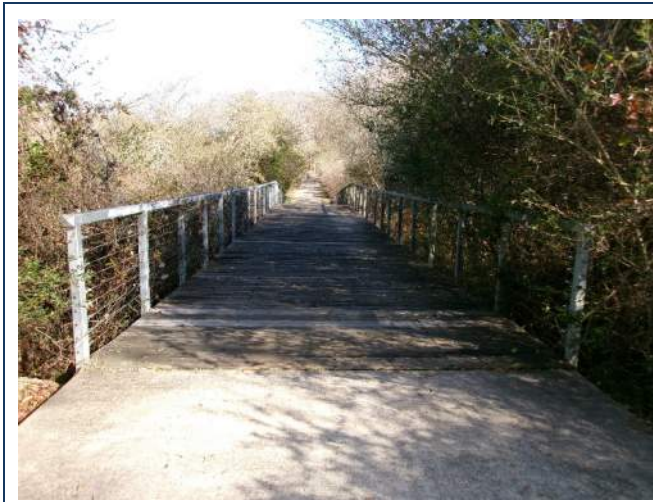
This trail bridge consists of a timber deck and timber glulam beams supported by concrete abutment caps and timber intermediate bent caps with timber piles. The bridge has a total length of 101'-0" over 3 spans, with an out-to-out measurement that matches the minimum horizontal clearance of 12'-0". The timber deck consists of 3"x8" deck boards that are counterbored to the top of the timber beams. The deck is supported by (5) glulam beams spaced at 3'-0", that measure 5 ½"W x 21"T in Spans 1 and 3, and 5 ½"W x 25 ¼"T in Span 2. The abutment caps are concrete, are below grade and are founded on an unknown foundation. The intermediate bents caps are glulam beams that measure 7"W x 11 ½"T with a splice over Pile 2 using steel galvanized plates and bolts. There are (3) – 10" diameter timber piles at each intermediate bent location.

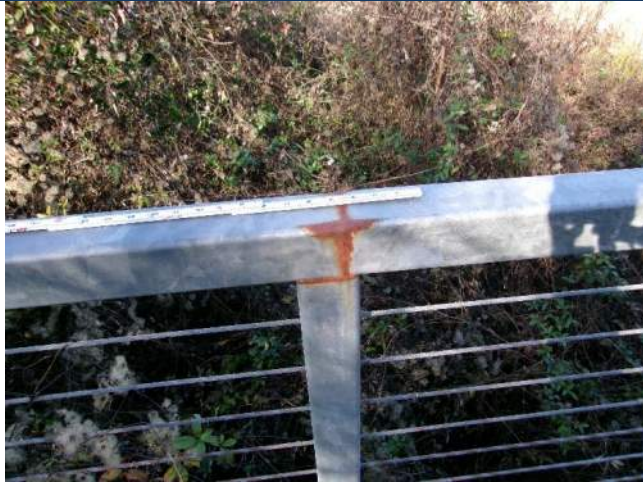
Surface corrosion on top of handrail and around welds

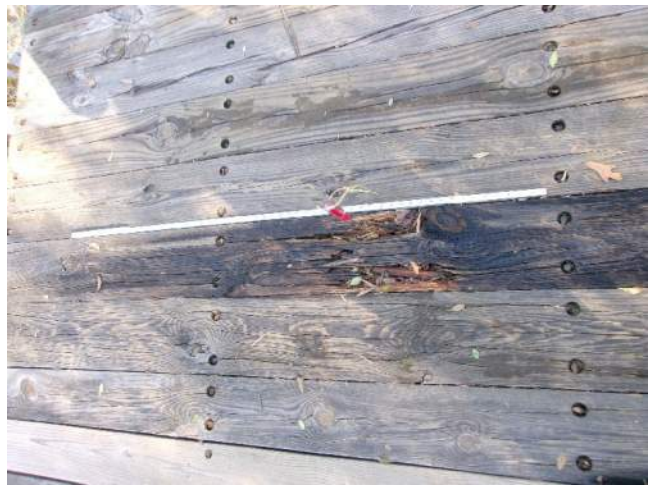
Area of deck board with splits and rot

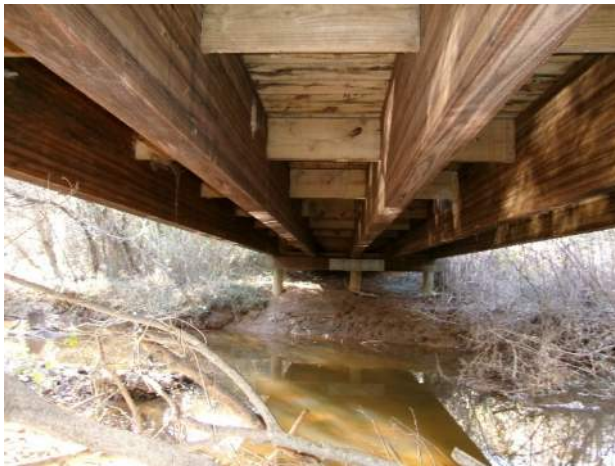
General underside (looking back from Bent 3)

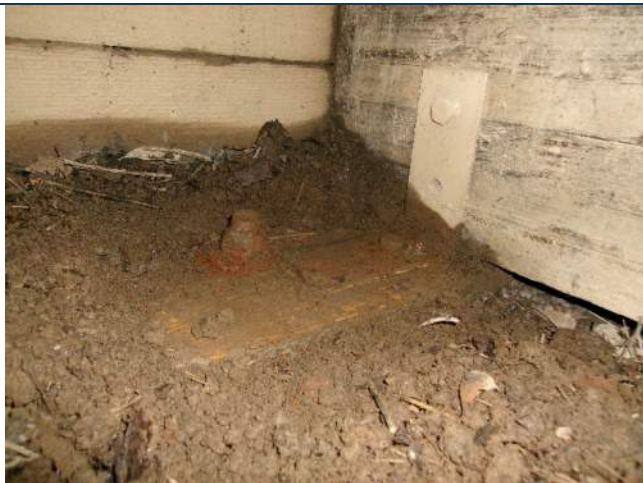
Corrosion of mud sill bolt and angle bolting beam to abutment at Bent 4

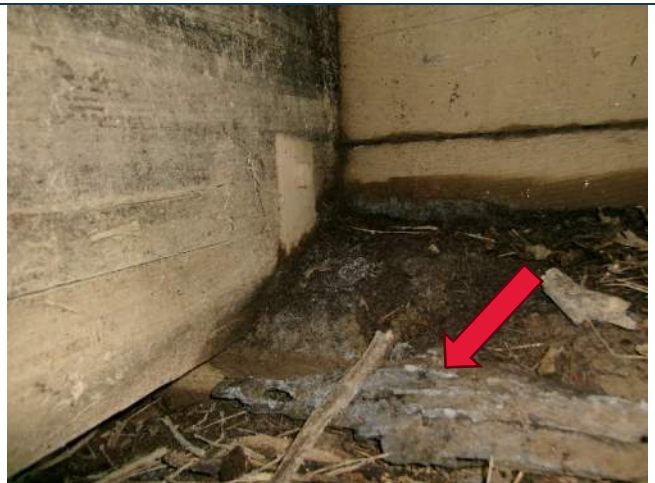
Dirt build up on top of Bent 4 cap, note the white mold

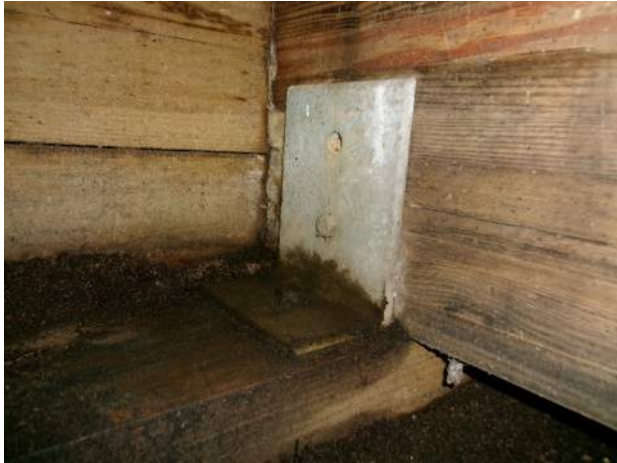
Dirt build up along top of Bent 1 cap that is retaining moisture

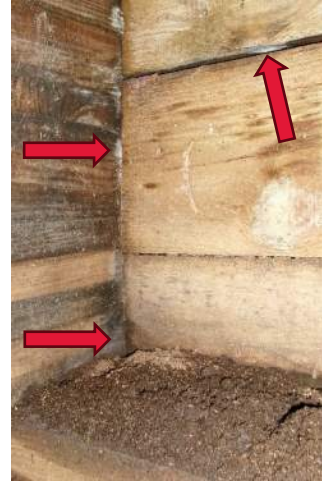
Dirt build up along top of Bent 1 cap, note the white mold growth

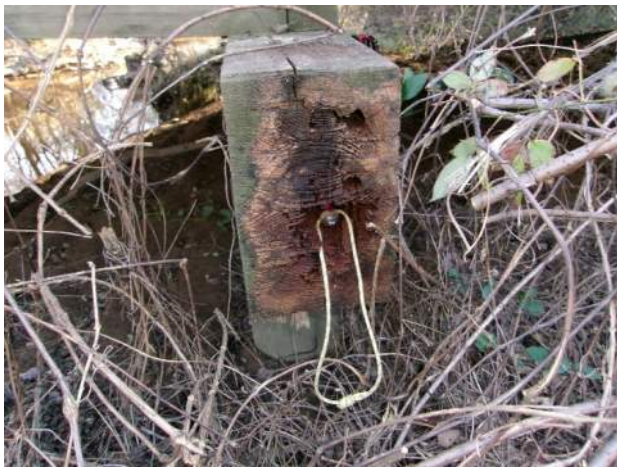
Rot in end of Bent 2 left cap
