REQUEST FOR PROPOSALS

BRIDGE MAINTENANCE & REHABILITATION PROJECT

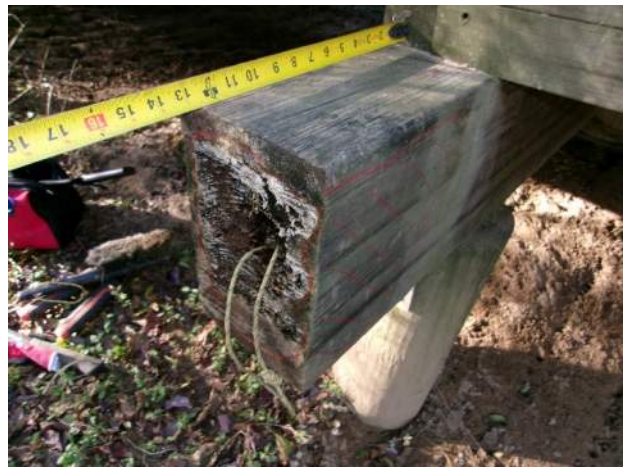
Rot in end of Bent 2 right cap

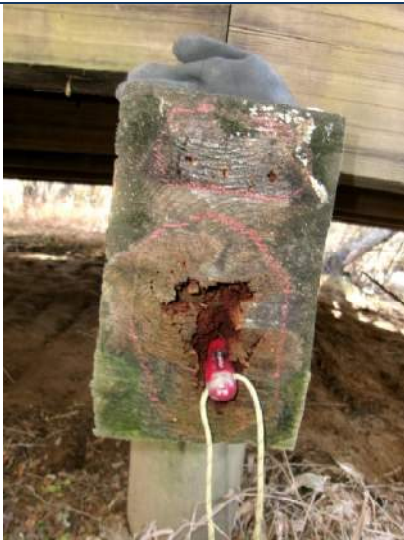
Rot in end of Bent 3 left cap

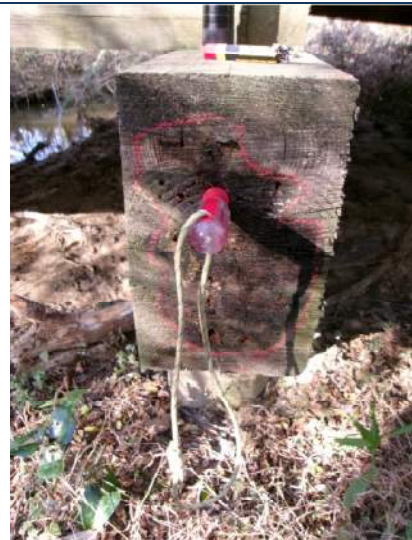
Rot in end of Bent 3 right cap

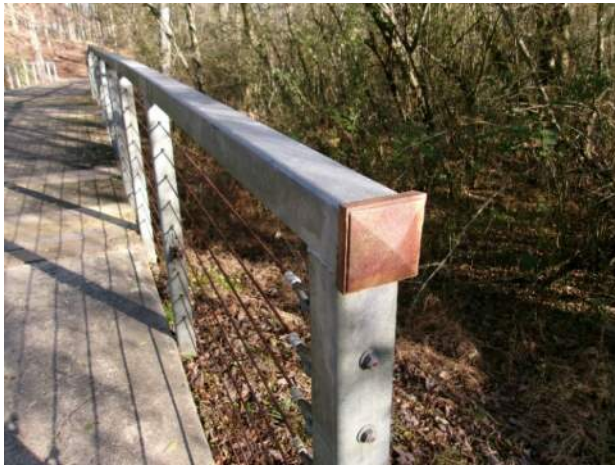
Surface corrosion of handrail end cap

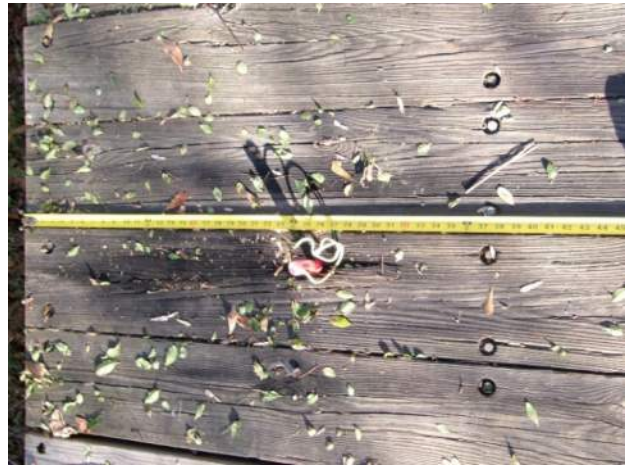
Typical of deck board with splits and rot

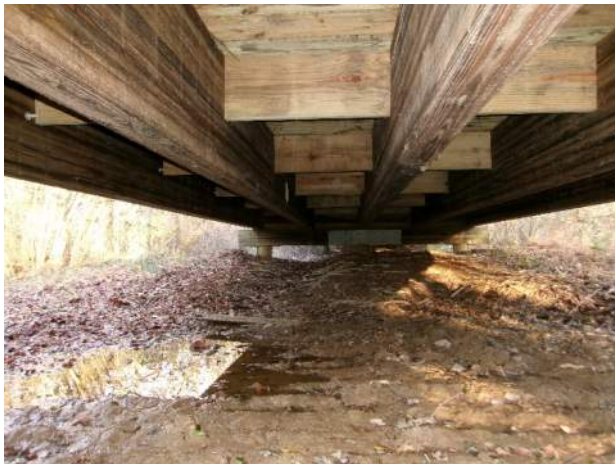
General underside (looking ahead from Bent 2)

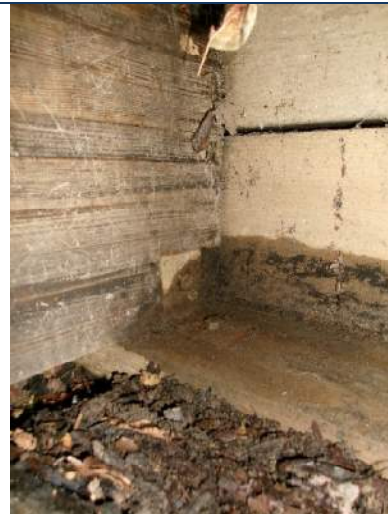
Corrosion forming on steel angle that bolts the beam to the mud sill at Bent 1

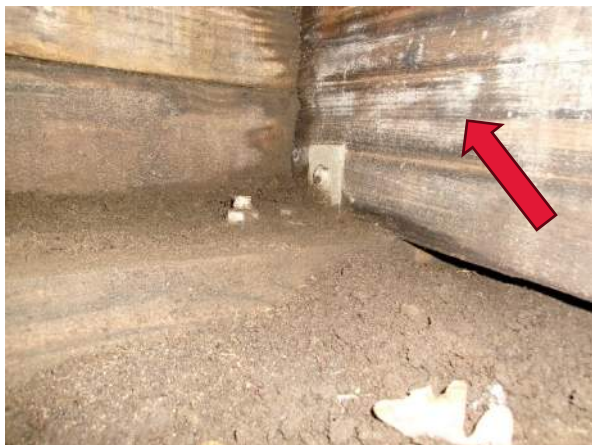
Corrosion forming along edges of steel angle at Bent 5, note the white mold

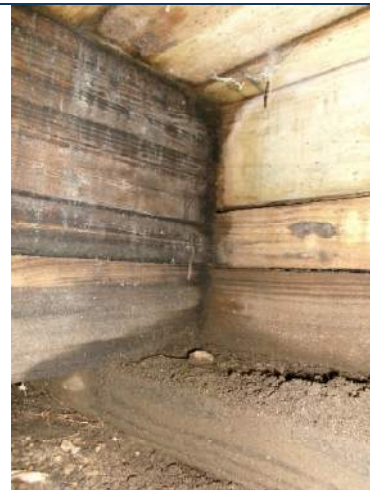
Dirt build up on top of Bent 5 cap

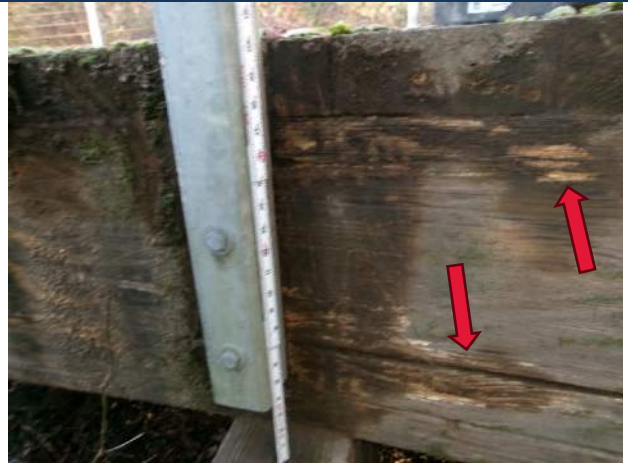
Dirt and moss growth on Beam 5 in Spans 3 and 4 is leading to soft rot

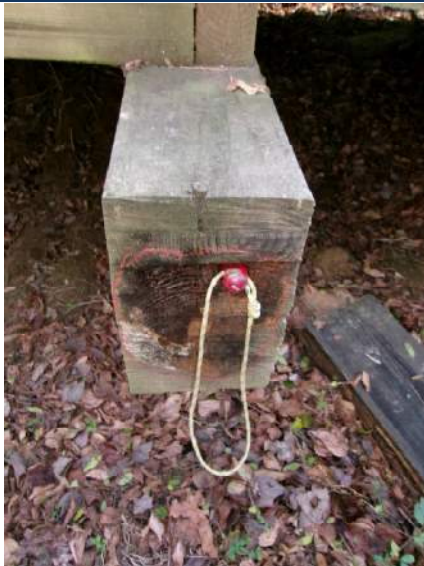
Rot in end of Bent 2 left cap

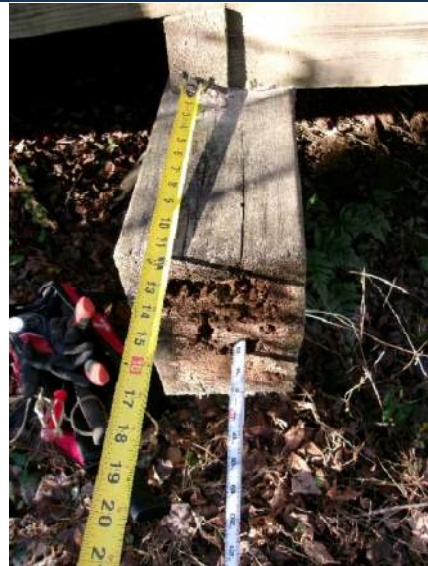
Rot in end of Bent 2 right cap

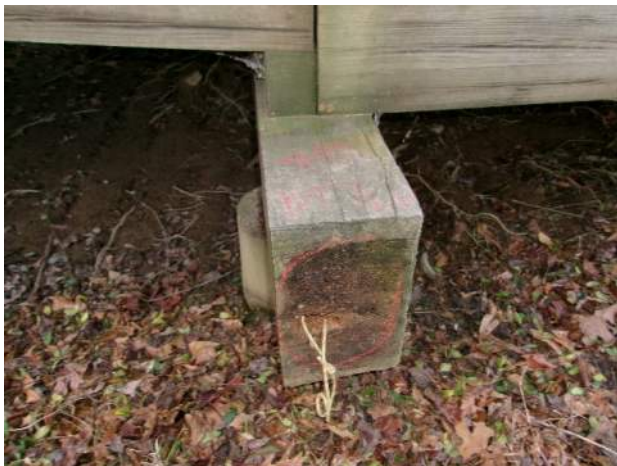
Rot in end of Bent 3 left cap

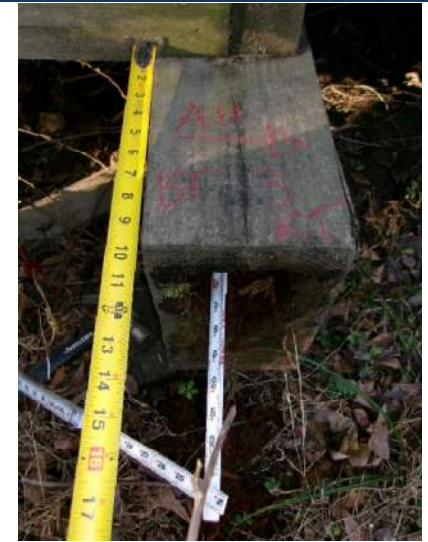
Rot in end of Bent 3 right cap

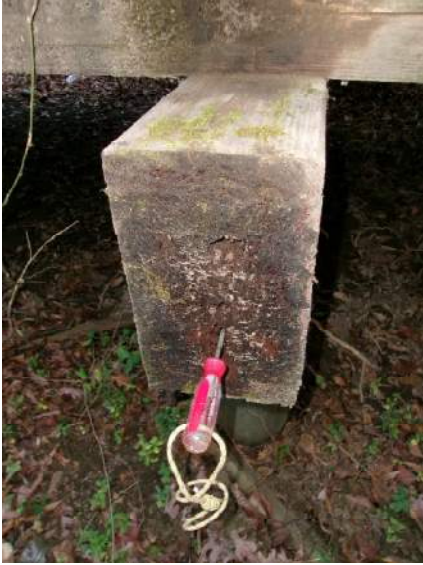
Rot in end of Bent 4 right cap, note the moss growth

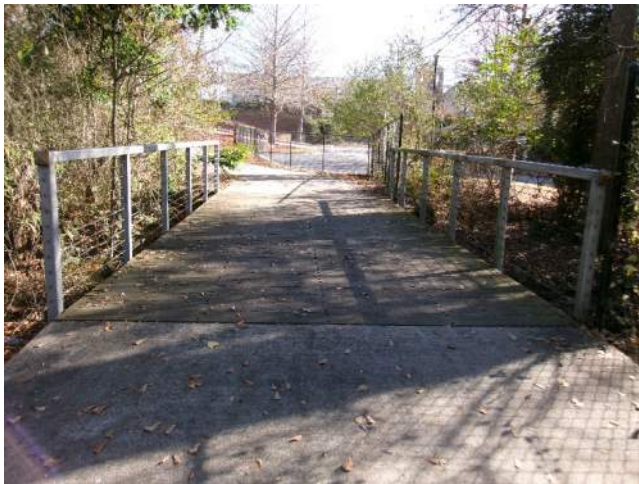
This single span bridge consists of a timber deck and timber glulam beams supported by concrete caps that are founded on an unknown foundation. The bridge length measures 25'-9", with an out-to-out measurement that matches the minimum horizontal clearance of 12'-0". The timber deck consists of 3"x8" deck boards that are counterbored to the top of the timber beams. The deck is supported by (5) beams spaced at 3'-0", and measure 5¼"W x 16⅝"T. The beams are bolted to a 3"x8" mud sill by steel angles and the mud sill is bolted to the top of the concrete abutment caps. The bridge has minimal vertical clearance over the waterway which makes inspection access difficult.

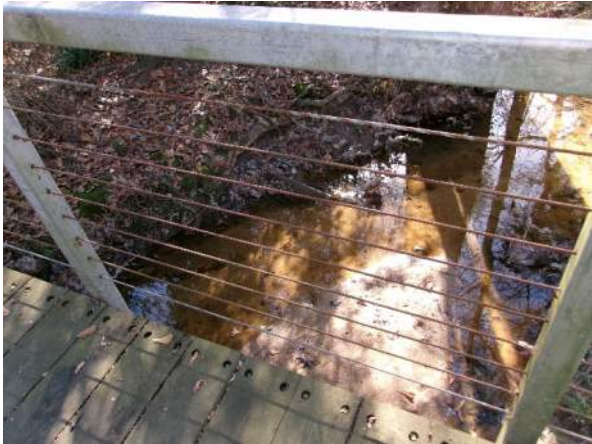
Surface corrosion forming on steel cables of handrail, note the green mildew on vertical posts

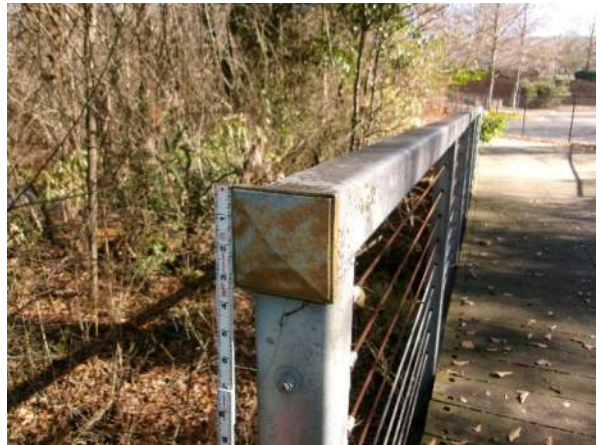
Surface corrosion forming on end caps of handrail

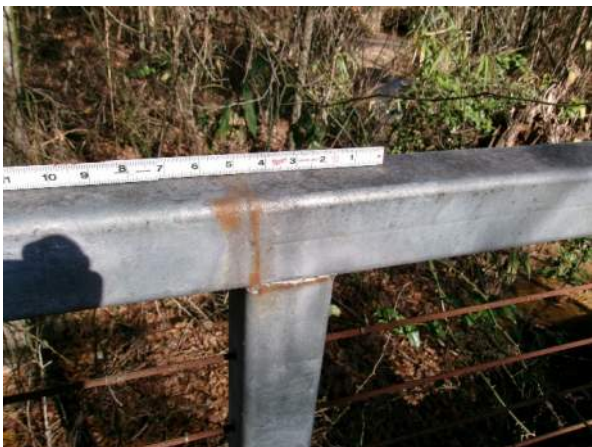
Handrail has localized areas of surface corrosion forming where galvanized coating is beginning to fail

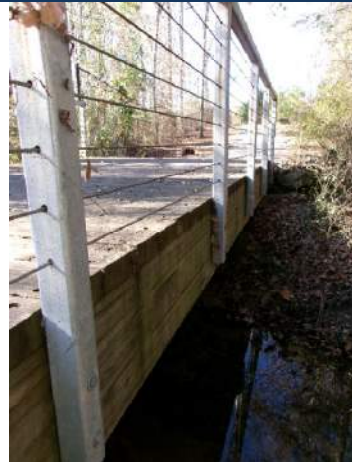
Typical of handrail connection to exterior beams (looking back)

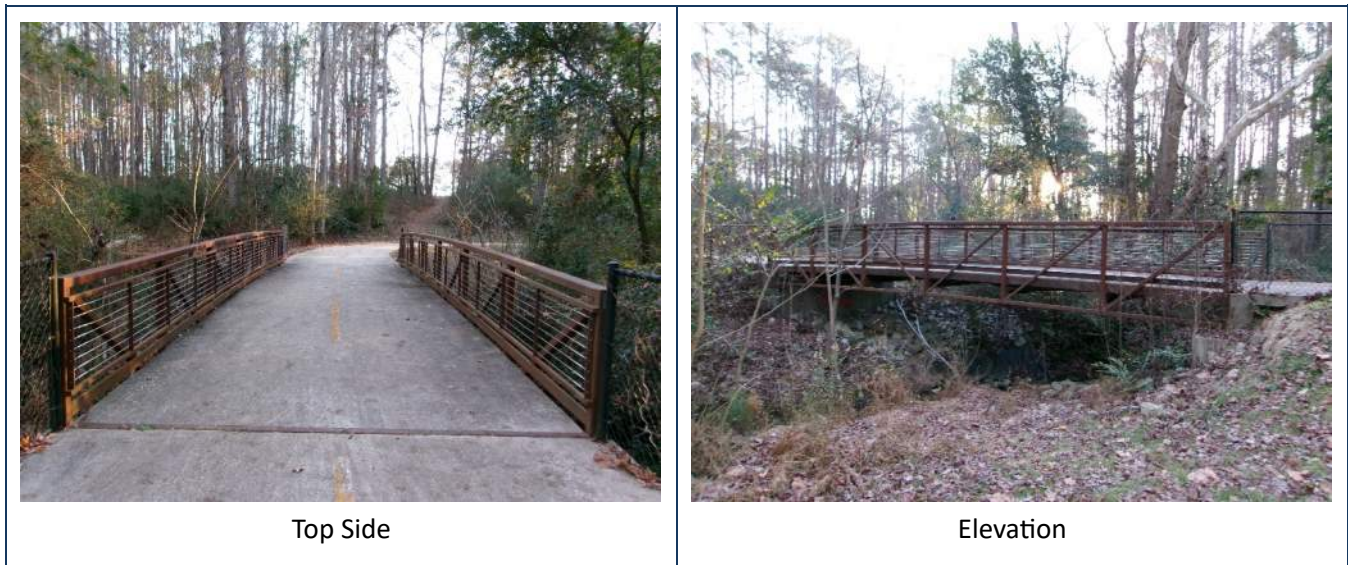
This single span bridge consists of a prefabricated steel truss with a concrete deck and stay in place metal deck forms. The bridge sits on concrete caps with an unknown foundation. The bridge length measures 40'-3", with an out-to-out measurement of 12'-3". The minimum horizontal clearance is measured to be 12'-0" between the bridge railings. The railings along both sides of the bridge consist of pretensioned epoxy coated steel cables. The steel members are a grade of weathering steel with galvanized steel deck forms.

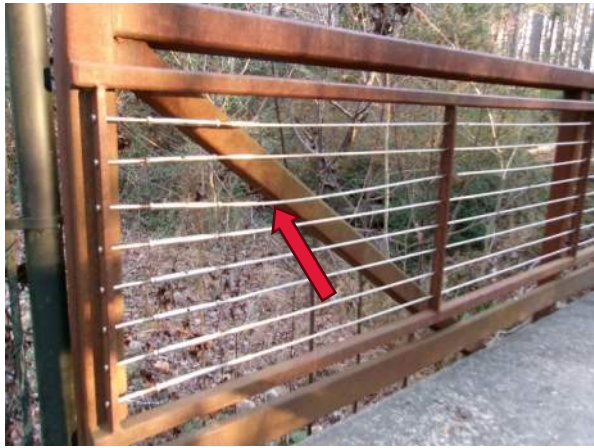
Loose steel cables of railing along left side of bridge

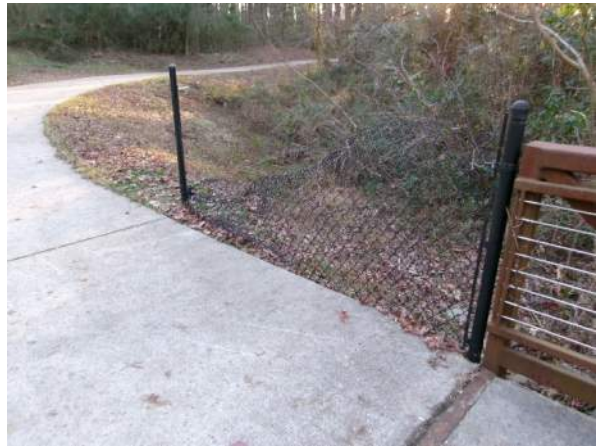
Damaged chain linked fencing at Bent 2 Right

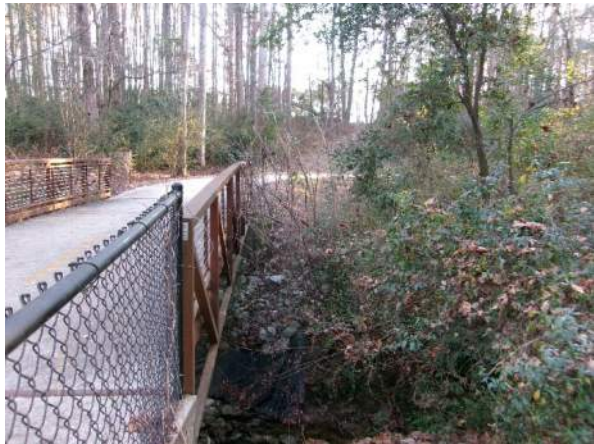
Heavy vegetation growing along both sides of bridge (looking ahead)

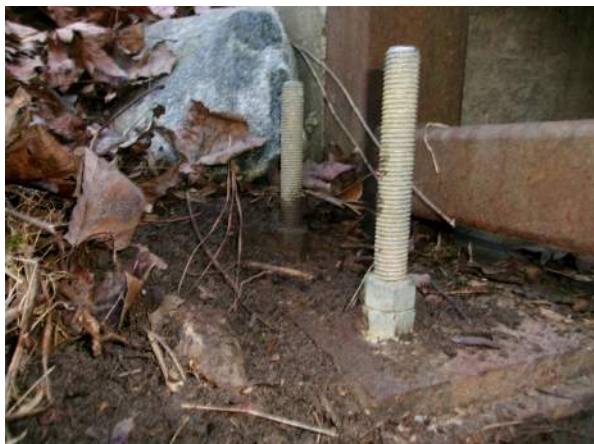
Protective coating of anchor bolts beginning to fail

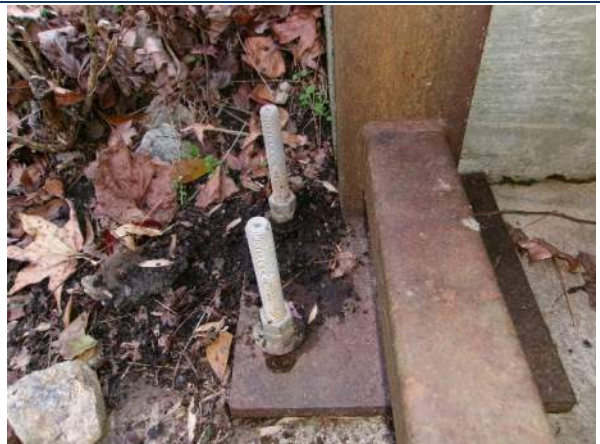
Dirt and debris clogging expansion slots of expansion bearing plates at Bent 2

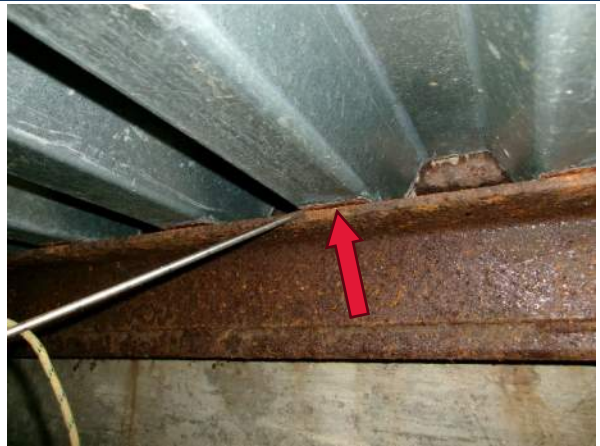
Corrosion forming on bottom of metal deck forms at contact points with weather steel members
